LOW VELOCITY IMPACT DAMAGE EVALUATION IN FIBER GLASS COMPOSITE PLATES USING PZT SENSORS

M J Santos^{a,*}, J B Santos^a, A M Amaro^b, M A Neto^b

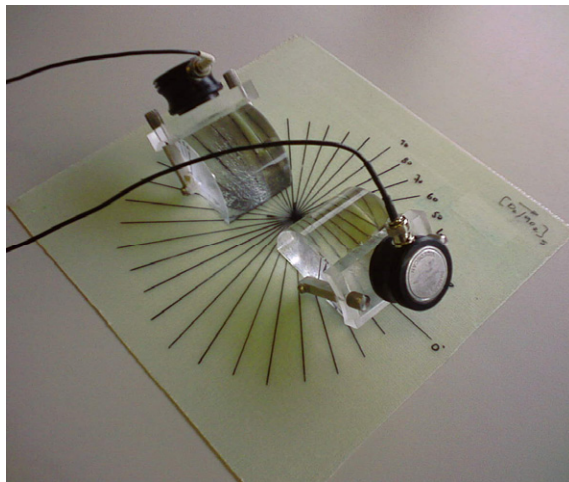
Fig. 1

Fig. 1. Experimental setup for Lamb wave detection and identification.

For detection and identification of the Lamb waves in the laminates the setup shown in Fig.1 has been used. Two Panametrics transducers with central frequency of 500 kHz were coupled to the laminate plates by plexiglas blocks with variable inclination. The transducers were glued to the blocks and coupling gel was utilized between blocks and the laminate plates. A Panametrics pulser/receiver generated the signals and a digital oscilloscope was used to visualize them after propagation on the plate. Then, the signals were transferred via a USB port to the computer for processing.

Using the previous set-up described in Fig.1 and proceeding with a rotation increment of 10° between each measurement, the wave propagation directivity patterns for S_0 mode were obtained for all analysed samples. For comparison purposes, an additional unidirectional fiber sample was tested, having a $[0]_{16}$ stacking sequence and 2.1 mm in thickness. Fig.4 illustrates the results for samples A and the $[0]_{16}$ one. As expected, for the unidirectional sample, the velocity for 0° direction is higher than the corresponding one for 90° direction, while for samples A the velocity is roughly the same in the cross directions. The results for the B, C and D samples were found to be similar to samples A.

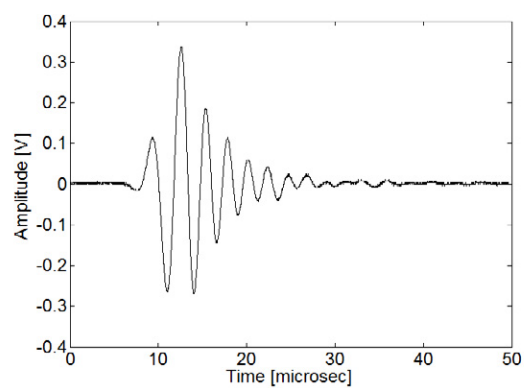
Fig. 2

Fig. 2. Typical collected signal for the laminate composite plate.

The symmetrical S_0 mode was selected, because the excitation of A_0 mode is not possible according to the co-incidence principle [36]. A typical collected signal is presented in Fig. 2.

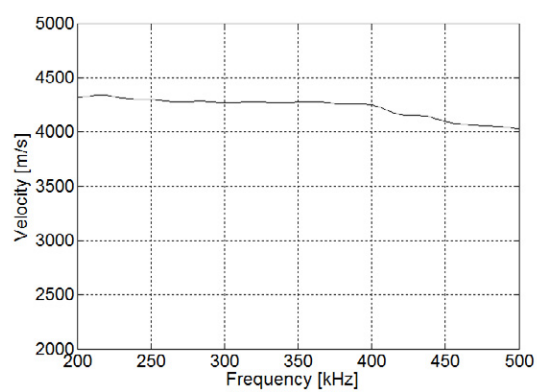
Fig. 3

Fig.3. Experimental S_0 phase velocity for samples A.

The correct inclination for the blocks was obtained maximizing the amplitude of the collected signals. For the selected A sample the inclination was around 40°, which is according to the co-incident principle. The phase velocity presented in Fig. 3, was obtained using the phase spectrum method for two signals collected

5 cm apart in 0° direction. The considered frequency range for the spectrum was 200 to 500 kHz due to the downshift frequency related to the filtering effect of the laminate composites. The small decreasing behaviour of the phase velocity is expected according to the theory in the low frequency regime.

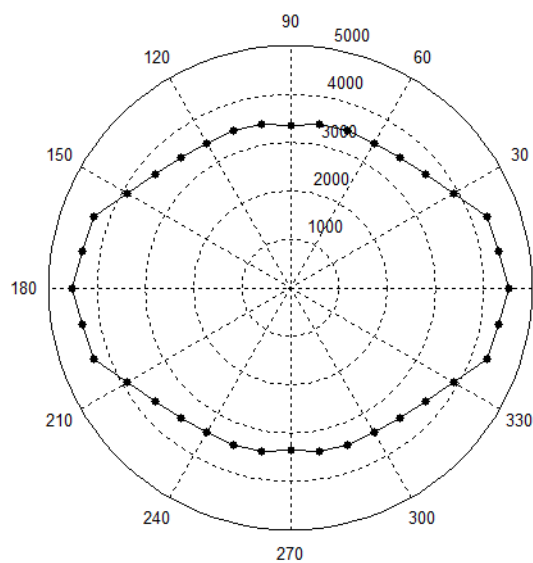
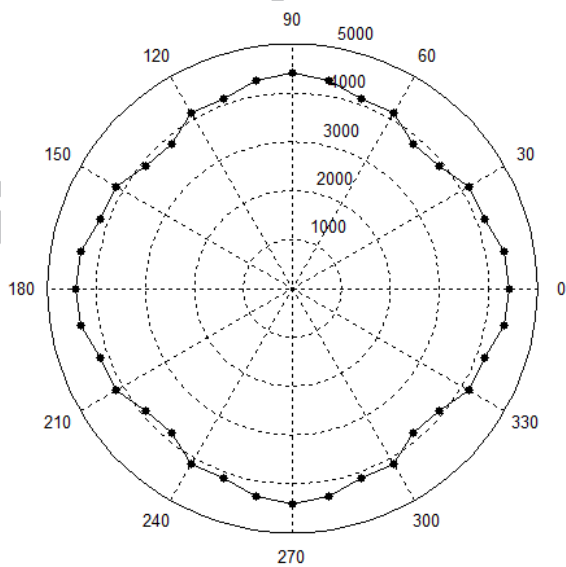
Fig. 4

Fig. 4. S_0 wave propagation directivity patterns for samples: (a) $[0]_{16}$; (b) A.

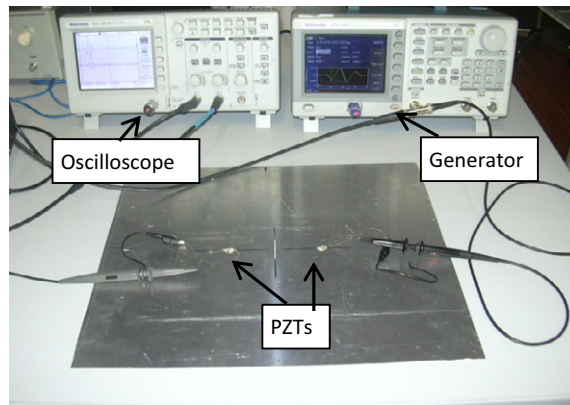
Fig. 5

Fig. 5. Experimental setup using an aluminium plate.

For Lamb waves generation the used PZT sensors were cut in square pieces of 7×7 mm from a PZ29 bar of 0.4 mm in thickness. For excitation, an arbitrary waveform generator (Tektronix AFG3022) was used to produce a 3-cycle toneburst with a Hanning window that was previously synthesized in Matlab. This windowing technique is used to narrow the signal bandwidth and to concentrate the maximum amount of energy into the desired frequency with a minimum spreading to neighbor frequencies. The signal was 10 V in amplitude. The PZT sensors were mounted in a pitch and catch configuration and the signals were collected as mentioned in section 3.2. The complete setup using a 1 mm thickness aluminium plate is presented in Fig. 5.

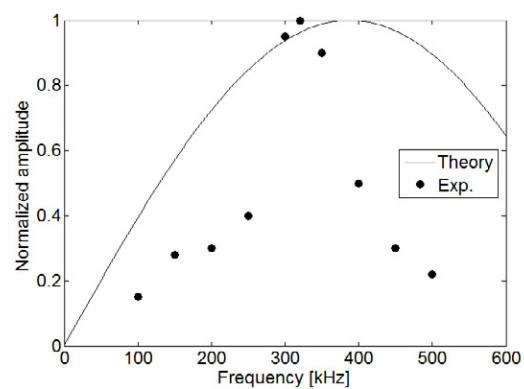
Fig. 6. Normalized S_0 Lamb wave tuning for a 7 mm length PZT placed on 1 mm thickness aluminium plate.

Fig. 6 shows the behaviour of the experimental normalized voltage amplitude at the receiver for a frequency sweeping from 100 kHz to 500 kHz as well as the theoretical values obtained from equation (1). The difference between the traces is related specifically to the imperfect coupling between the PZT and the plate, and also to the small discrepancies in PZT length. Nevertheless, if optimal resonance frequency is desired, which is mostly the case; the method could be used with reasonable accuracy. Similar results are reported by Giurgiutiu [22] that mentions the necessity of an effective PZT length adjustment to about 90% of its real length.

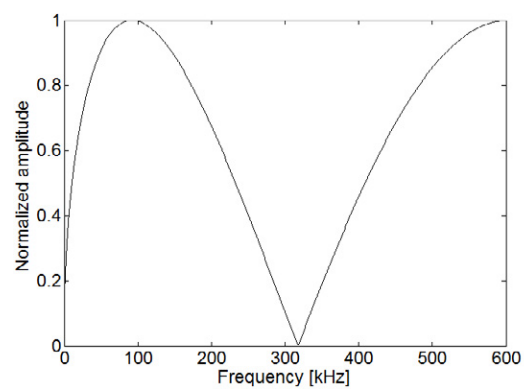
Fig. 7

Fig. 7. Normalized A_0 Lamb wave tuning for a 7 mm length PZT placed on 1 mm thickness aluminium plate.

For the considered aluminium plate, the A_0 mode has the predicted response shown in Fig.7. Experimentally, it was not possible detecting this mode, as expected. The reason for that is probably related to the coupling medium used between the PZT and the plate.

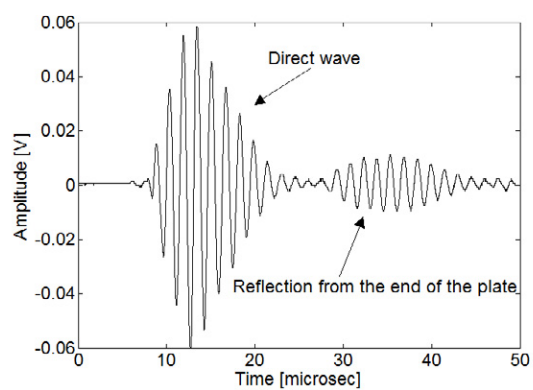
Fig. 8

Fig. 8. Fundamental symmetrical S_0 mode in the composite plate.

For the composite plate, the PZT sensors were mounted 100 mm apart on the surface using conductive glue. A frequency sweep allowed verifying that the maximum signal in the receiver was obtained at 320 kHz. Using time of flight, it has easily been proved that the signal corresponded to the fundamental symmetrical mode S_0 . A typical signal propagating in a composite plate is presented in Fig. 8, showing the direct signal and the reflection from the plate edge.

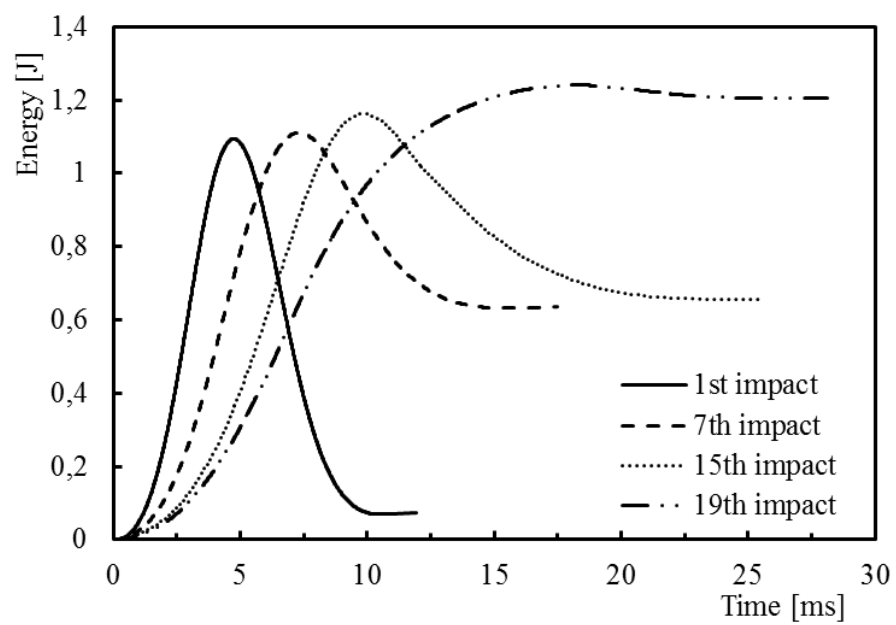
Fig. 9. Typical energy versus time curves for samples A.

Low velocity impact tests were produced using a drop-weight testing machine Instron-Ceast 9340 with a hemispherical impactor of 10 mm in diameter and a mass of 3.4 kg. The specimens were centrally supported. Fig. 9 represents the typical energy versus time curves obtained for samples A. The beginning of the curve plateau energy coincides with the loss of contact between the striker and the specimen, and this energy level corresponds to the absorbed one by the specimen [37]. In this context the dissipated energy is calculated as the difference between the absorbed energy and the energy at the peak load.

increasing is more pronounced for the samples A than for samples B and C, considering the same impact energy (1 J), due to the lower thickness presented by the A ones. Also, samples B, C and D were submitted to higher energies, ranging from 3 to 10 J, leading to a jump in the damage area. The observed damage area variations, for all tested samples, agree with the higher absorbed energy with the impacts number according to the results shown in Fig. 9 and 11.

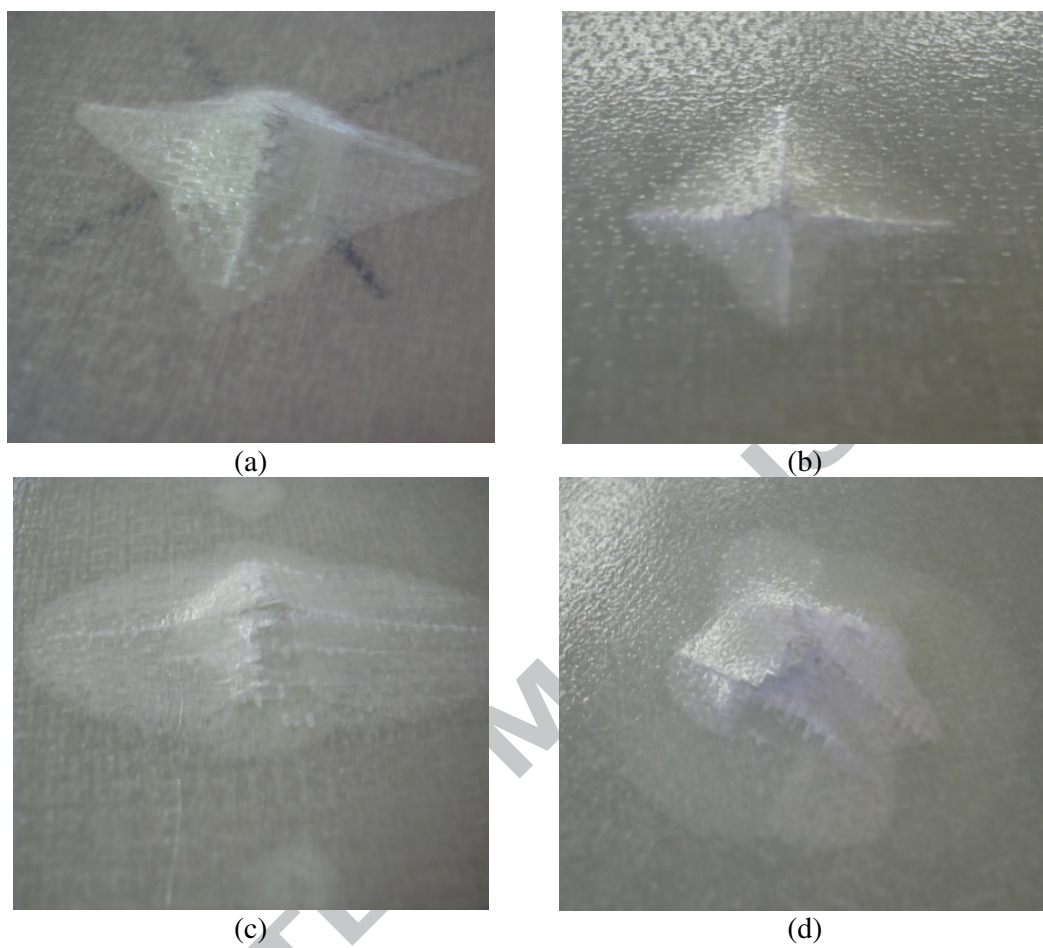
Fig. 10. Damages occurred after the last impact for samples: (a) A (19th); (b) B (22nd); (c) C (27th); (d) D (19th).

As the used glass plates are translucent the damage images were obtained by photography collected from the opposite side of the impact (back face). Images for the A, B, C and D samples showing the damages after suffering the last impact are shown in Fig. 10. The different damage shapes and sizes are essentially due to the stacking sequences, thicknesses and used energies. Fig. 10 (a) and (b) show a damage, which shape presents two lobes oriented on the fibers direction of the adjacent lower ply (0°), while samples in (c) and (d) do not reveal those two lobed shape because of the presence of multiple superposed delaminations at the several interfaces among the different oriented layers.

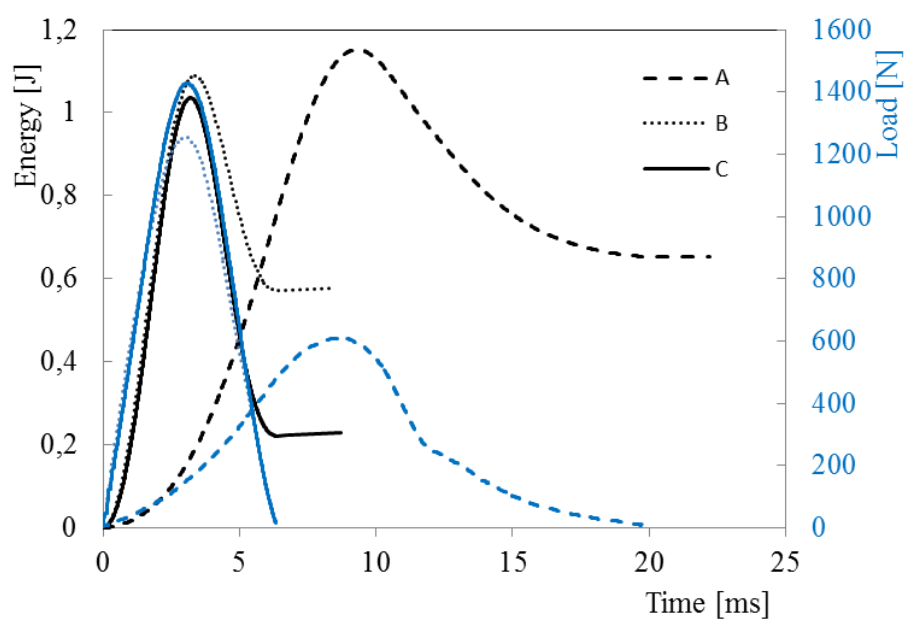
Fig. 11

Fig. 11. Typical load-time and energy-time curves for laminates impacted at 1 J, after the 15th impact.

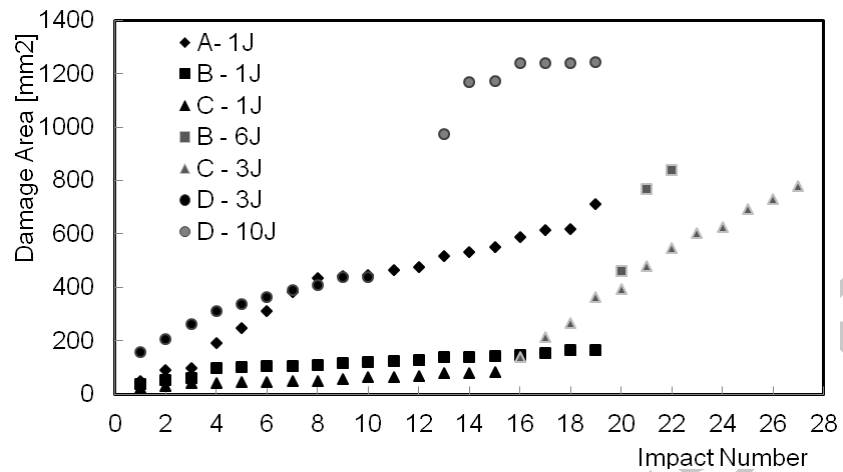
Fig. 12. Damage area versus number of impacts for all studied samples.

According to Sevkati et al [15], when the energy absorbed by the composite is small, the impactor bounced back and the damage area is also small. If a major energy of impactor is absorbed by the composite various modes of damage can appear with the consequent increase in size. Such is demonstrated by the graphical results outlined in Fig. 11 and 12. Fig. 11 shows the typical energy-time and load-time curves for the 15th impact carried out with energy of 1 J for samples A, B and C. It can be observed the higher load is obtained for the specimen C corresponding to the lower absorbed energy. On the other hand, the specimen A shows a higher absorbed energy and a lower load. The curves for the other impact numbers are similar. In Fig. 12 is presented the relation between the damage area and the number of impacts for all tested samples. For all kind of samples it is observed a damage area increasing with the number of impacts. However, that

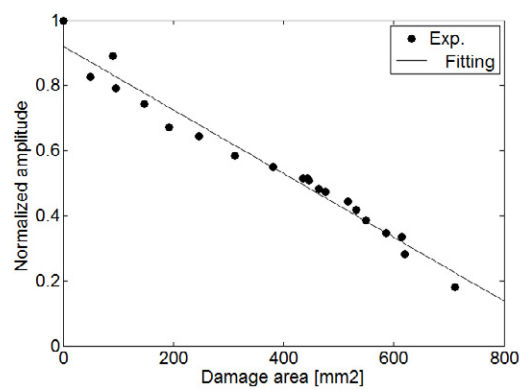
Fig. 13

Fig. 13. Signal amplitude versus damage area for samples A.

For evaluation of the impact effects in the fiber composite plates it was used the methodology presented in section 3.3. A pair of PZT sensors was previously bonded on each plate and after each impact the signals were acquire and processed. Next, the damage area was correlated with ultrasound parameters, like the amplitude and time shift as they provided the best results. The normalized peak to peak amplitude versus damage area for samples A is illustrated in Fig. 13. A high linear correlation between these two parameters ($R^2=0.968$) was obtained. Concerning to samples C, a high correlation was also observed. Unlike, samples B and D presented very low correlation values. As samples A and C present broken fibers from the beginning of the tests and samples B and D only for the last impacts, it can be inferred that the broken fibers influence greatly the amplitude parameter.

Concerning the fibers-breakage, the amplitude appears as a useful parameter to predict its occurrence. In fact, for the samples A and C where the fibers-breakage was observed after the 1st a 3rd impacts, respectively, the correlations between the damage area and amplitude are high. On the contrary, for samples B and D where the fibers-breakage happened only for a higher impacts number, the correlations are low.

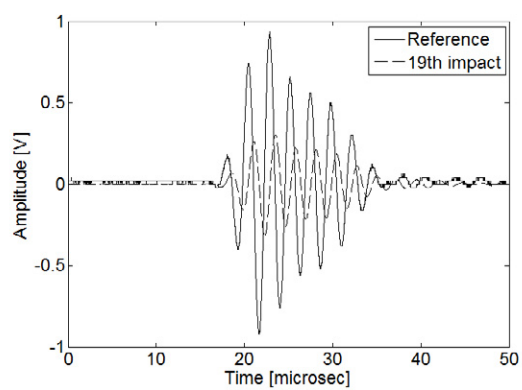
Fig. 14. Signals for a reference selected sample A and after 19th impact.

where s is the time shift between signals and N is the number of samples. The time shift s is obtained for the maximization of the function $R(s)$. Fig. 14 depicts the time shift between the reference signal and the signal after the 19th impact carried out on a selected A sample. The damage area versus time shift is shown in Fig. 15. It is observed an increase of the time shift with the damage severity, which is a consequence of a plate deformation that changes the ultrasound wave propagation path. The time shift approach was also applied to the other ones. For samples A, C and D a high linear correlation between the time shift and defect size was observed. For samples B, that correlation is lower. The results for amplitude and time shift parameters are summarized in Table 3.

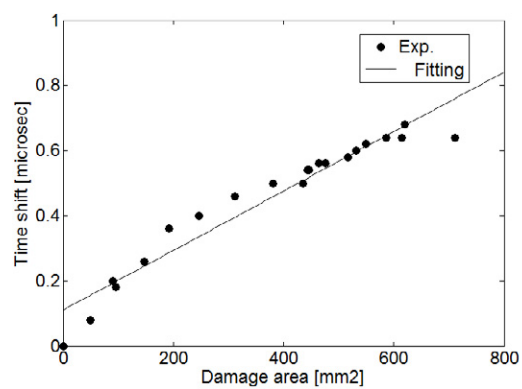
Fig. 15

Fig. 15. Time shift versus damage area for samples A

Considering the results for the time shift (see table 3), good correlation is always possible for damage size (moderated for samples B) independent of fibers-breakage occurrence.
